Master's Thesis

The structural intervention of
St. Torcato Church:
documentation and analysis
of the strengthening works

University of Minho

Year: 2014

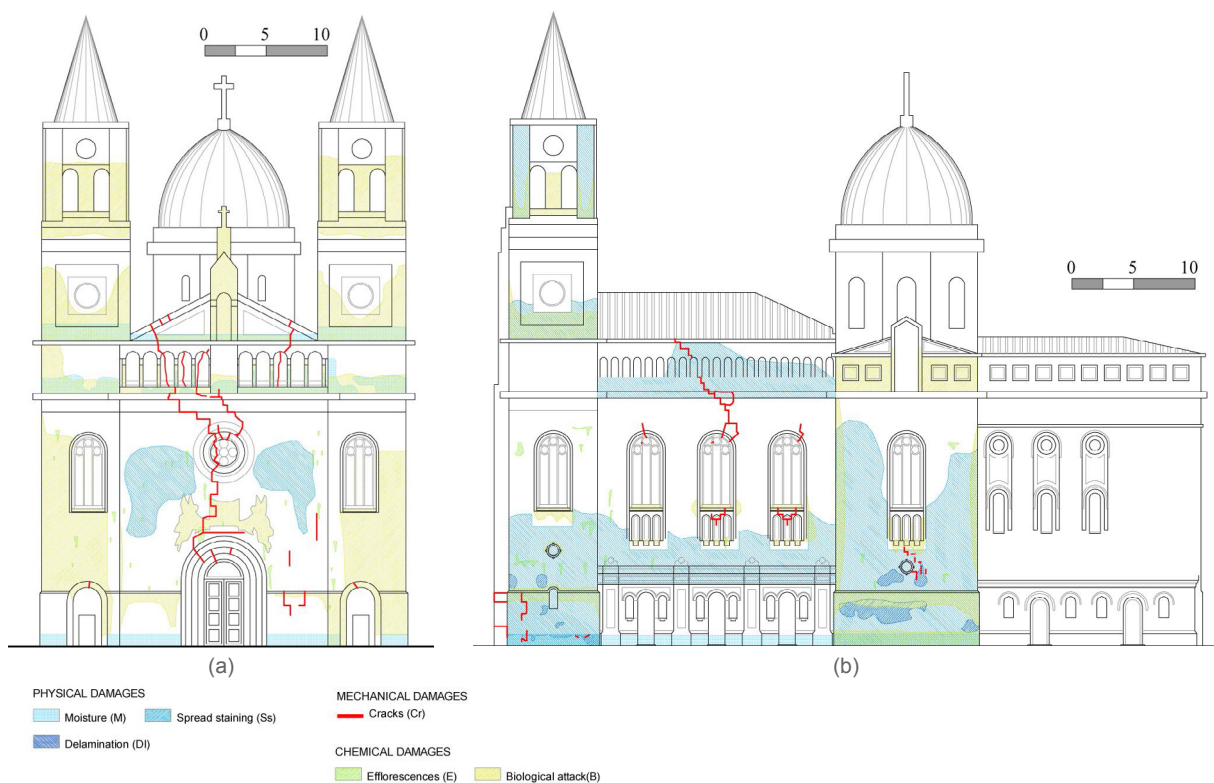
The church is affected by several structural and non-structural decays. The external walls present discolorations, delamination, encrustation, patinas, soiling, corrosion of the metallic parts and biological attacks. Causes and intervention methods of those pathologies were suggested by SAHC students during 2013. The actual damage pattern has been well represented by the students (Figure 3.12).

Figure 3.12: Damage map: (a) façade (b) eastern elevation (Ogrizovic et al., 2013)

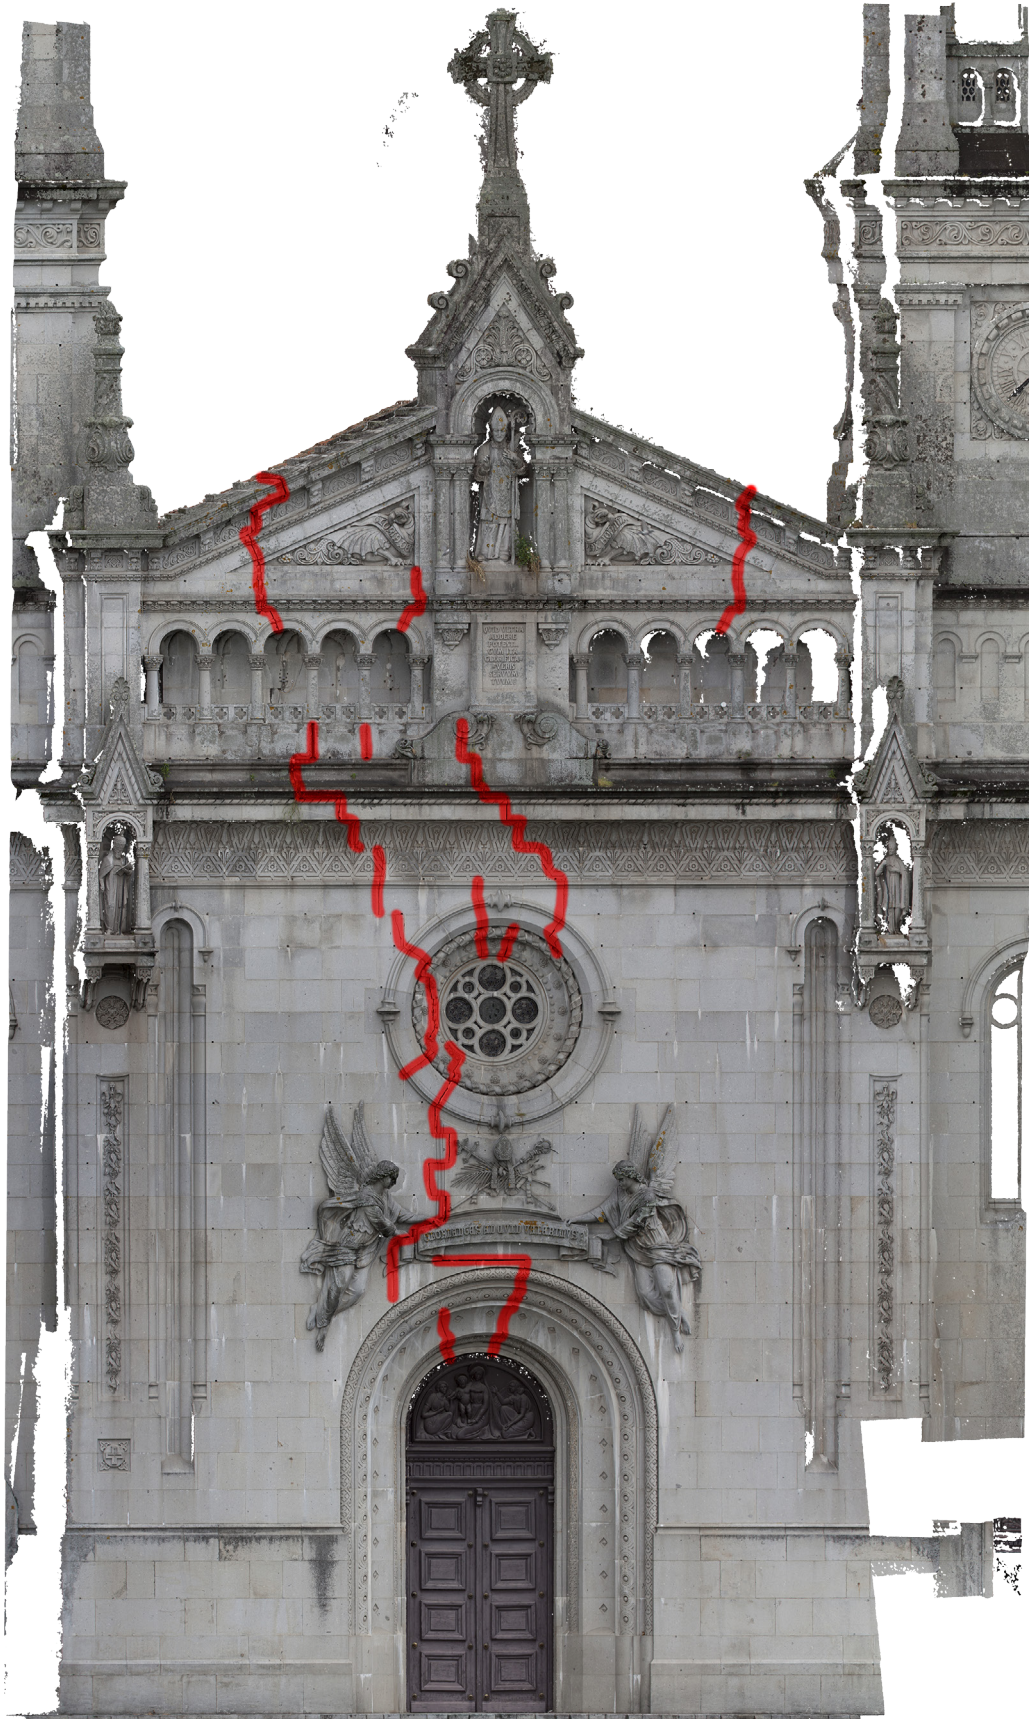
However, the most critical damage phenomenon is represented by the cracks that are developing on bearing walls and balconies. In fact, the main façade of the Temple is affected by a several cracks that reach 50 mm of width in some parts. The crack starts on the top of the main door and develops until the rosette, where it forks and proceeds up to the balustrade and the tympanum. It can be inferred that the area bounded by the cracks, that in some points are passing-through, represents a macro element detached from the rest of the façade. The crack pattern can be seen in Figure 3.13 and 3.14.

Figure 3.13: Identification of the crack in the façade, based on photogrammetric survey of Sánchez Aparicio

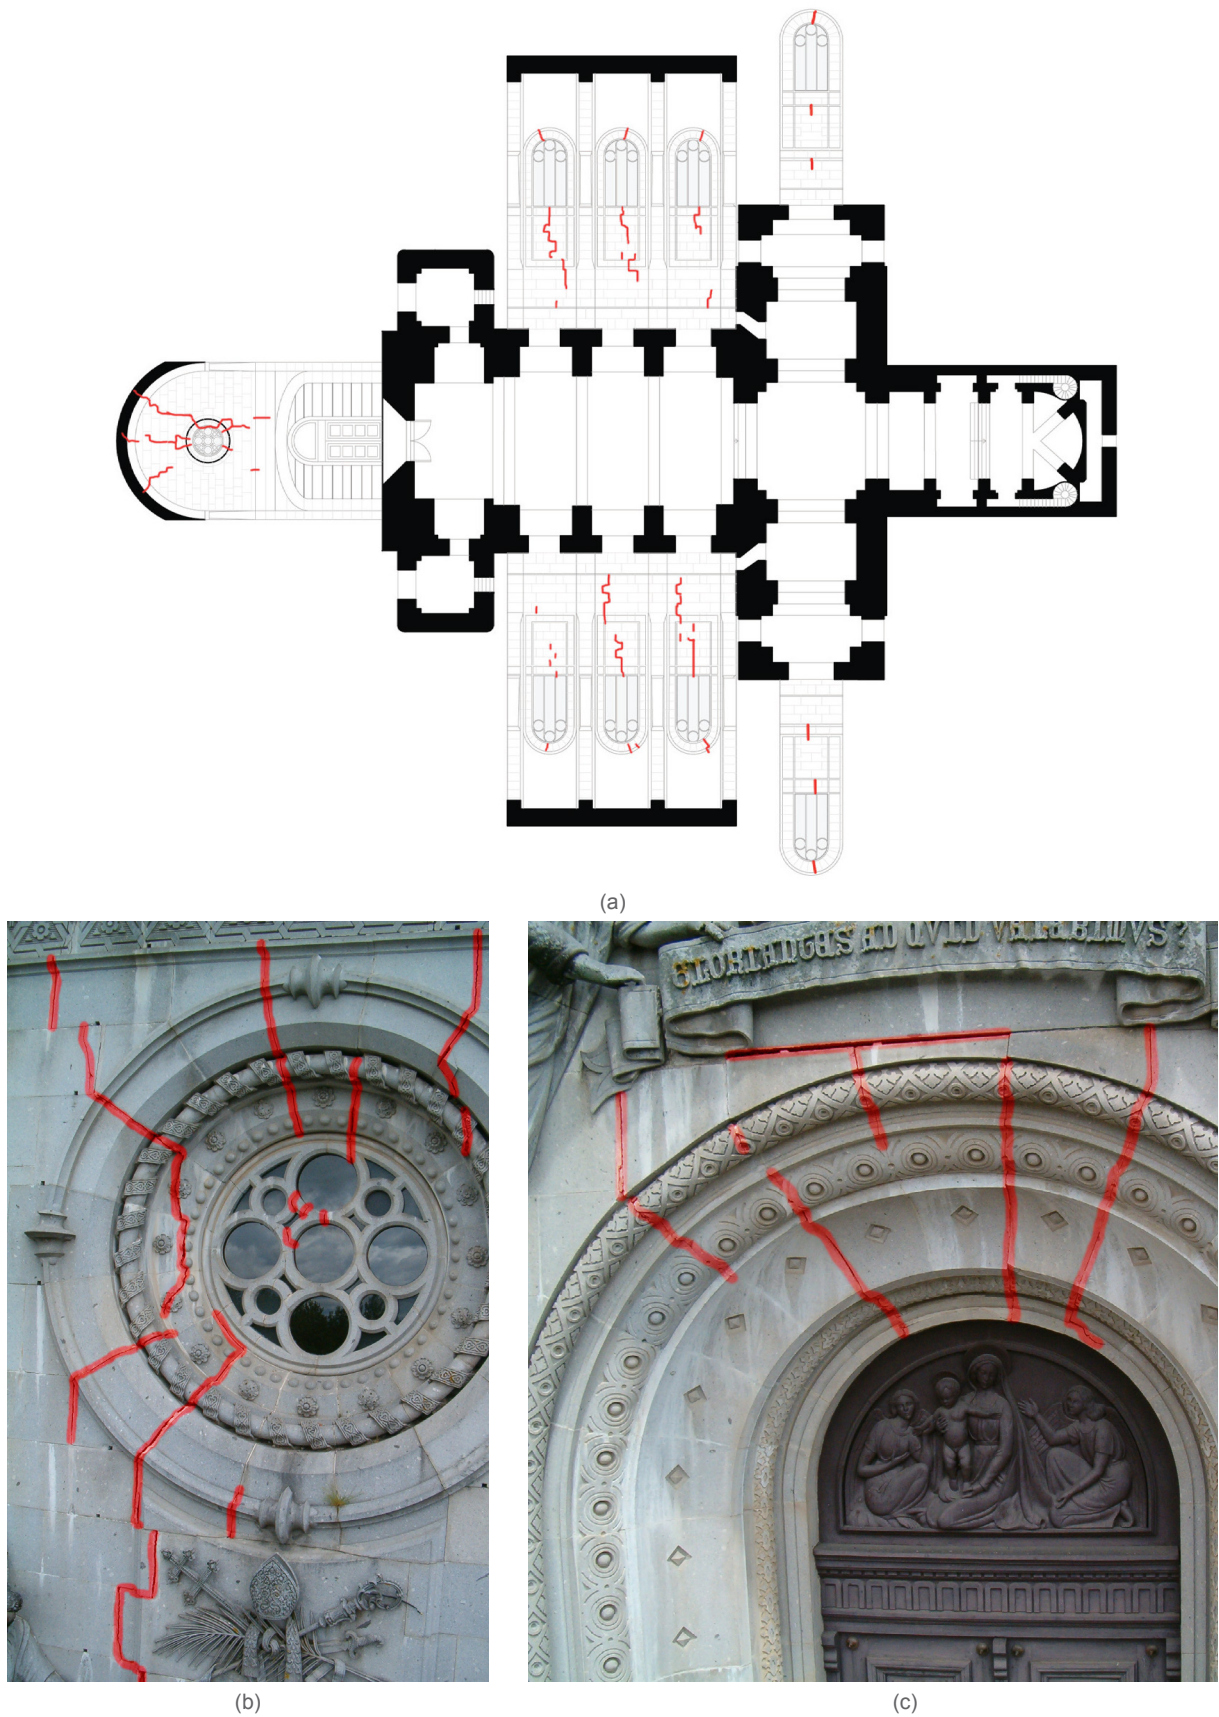
The balustrade presents five vertical cracks with maximal width of 5 mm, spaced approximately one meter between them. The major cracks of the façade are extended to the interior wall of the choir and on the upper part of the barrel vault. In in the choir the prolongation of three of the main cracks are visible on the floor. Moreover, in the main nave of the church is visible a horizontal crack that passes through the central part of the barrel vault.

Both sides of the buildings are affected by cracks, with maximal width of 20 mm, in the keystone of the first two rows of arches. Such damages are protracted until the roof (Figure 3.14).

Figure 3.14: Cracks of S. Torcato: (a) scheme of the the damage patter in the interior of the church defined by Gutschoven (b) detail of the cracks visible on the rosette (c) the damage revealed on the main entrance

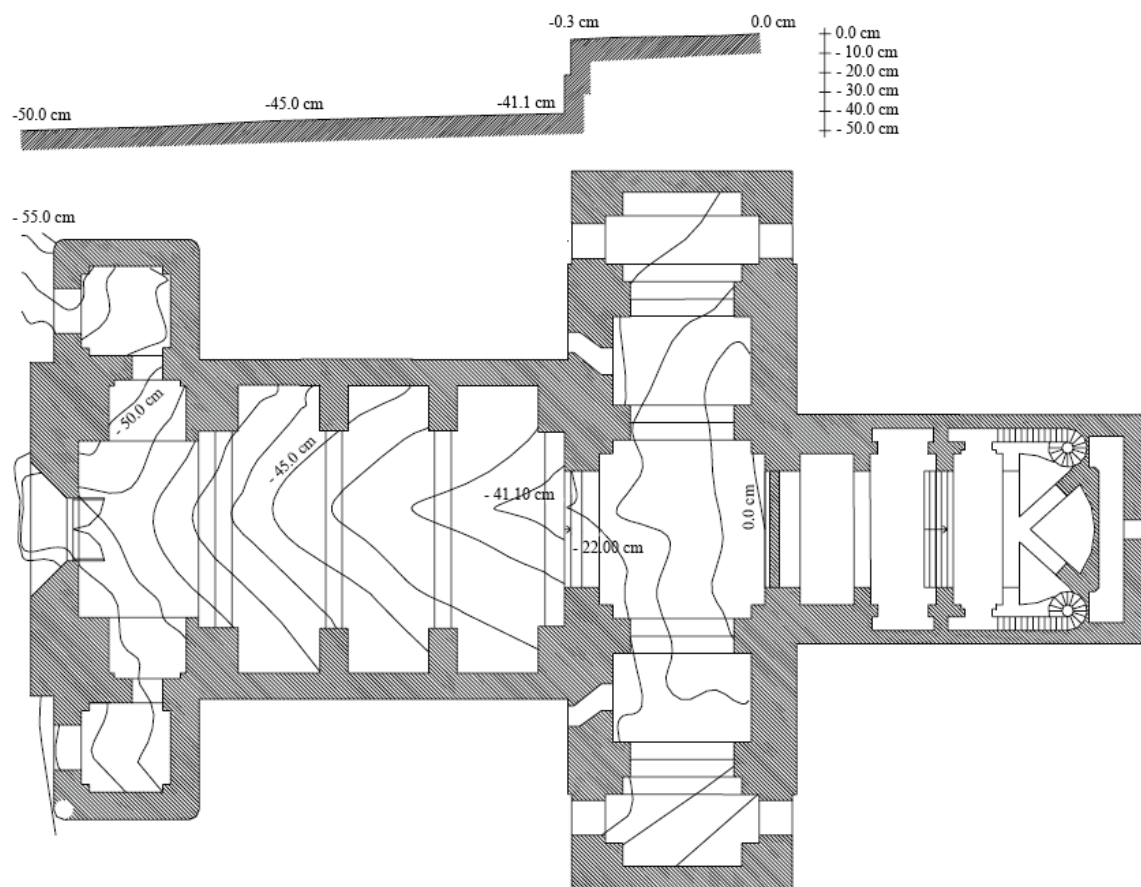
The results of the displacement monitoring confirmed the hypothesis of the differential settlement of the subsoil. It was possible to observe that the entire building, with the exception of the apse, is basically sinking following the distribution of the mechanical resistance of soil layers.

Figure 3.17: Plan that shows the distribution of the difference in level of the pavement (Lourenço and Ramos, 1999)

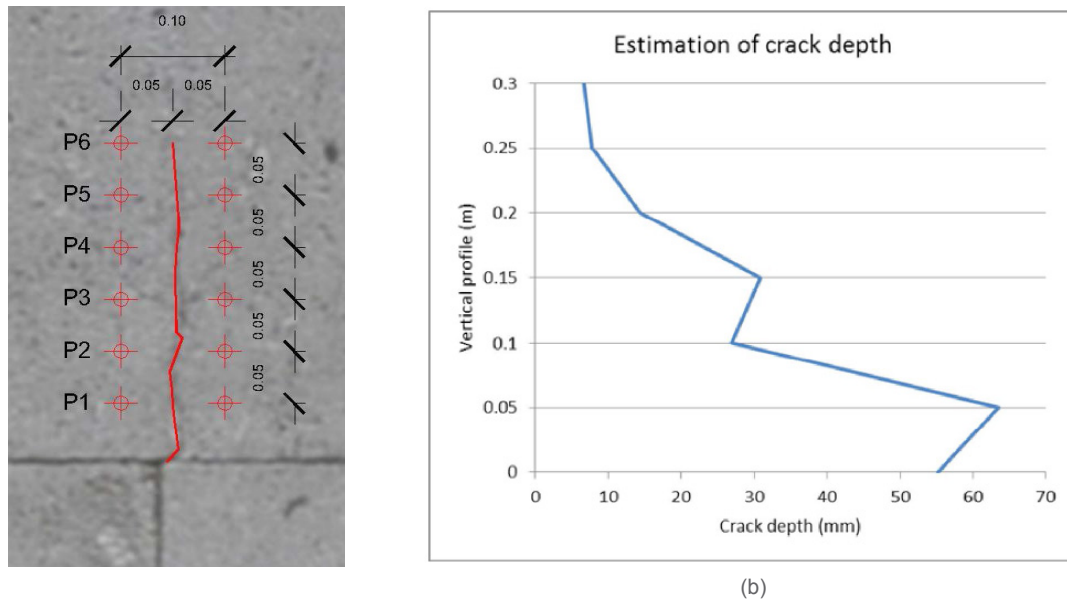
Figure 3.33: Ultrasonic tests performed by students on a crack (a) locations and levels of the crack depth readings (b) crack depth results (Facelli G. et al., 2013)

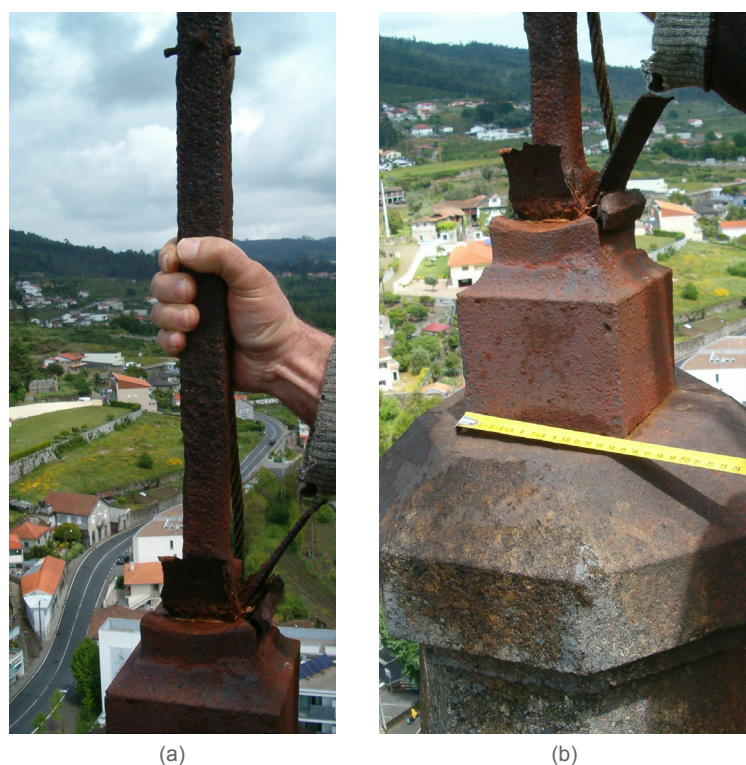
Figure 5.3: The visual inspection on the crane: (a) the base of the cross was severely affected by corrosion (b) the measuring of the cross

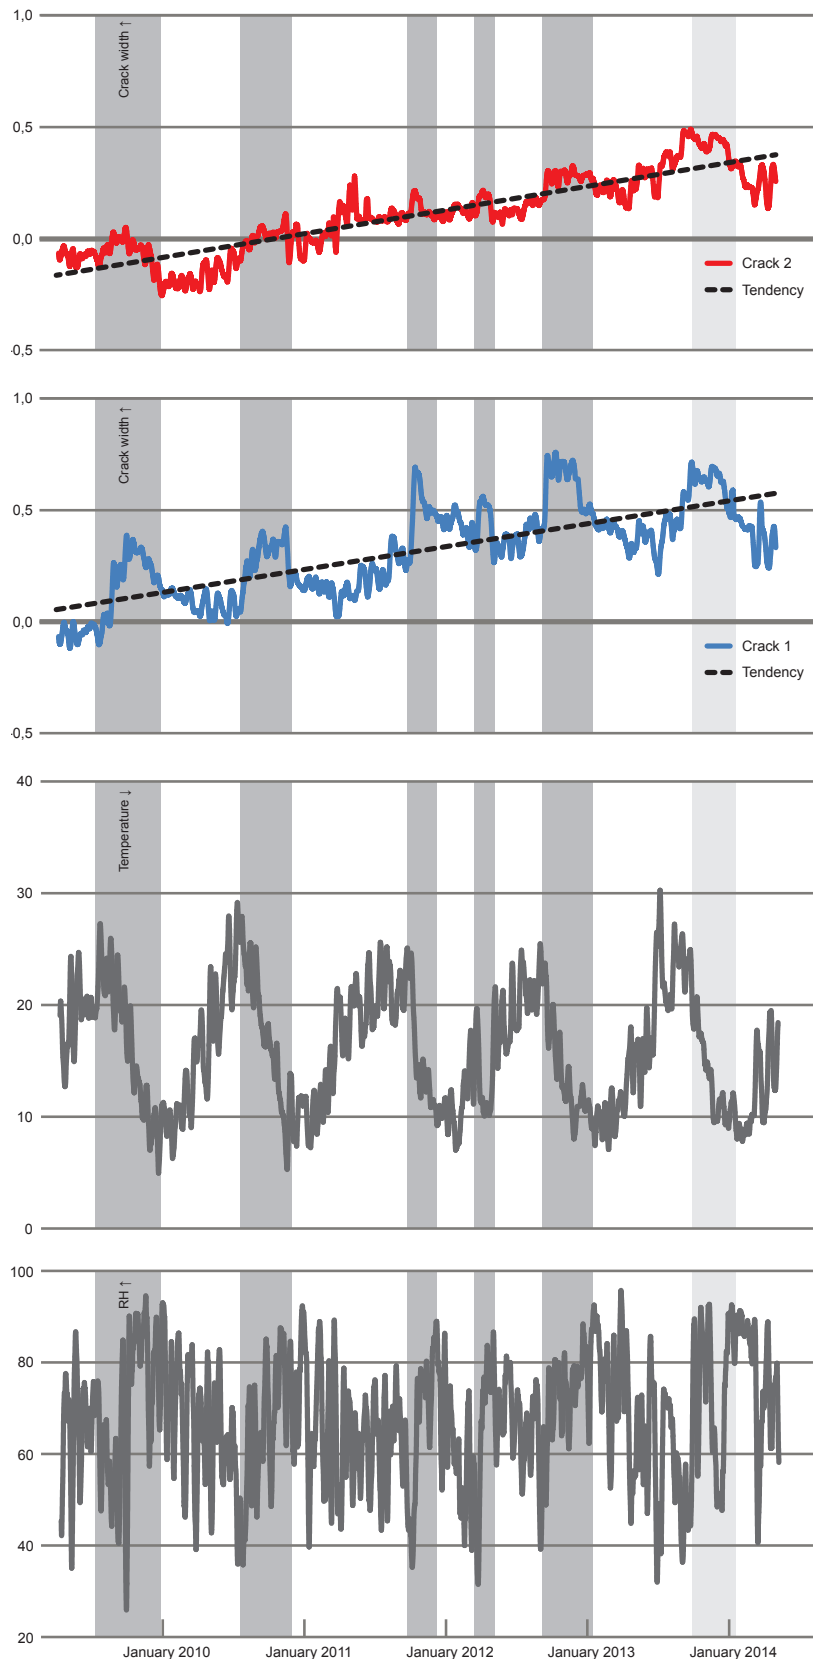
Figure 6.2: Analysis of the crack monitoring data. The gray pattern shows the behavior of the slits: both cracks width increase when the temperatures drop down and the humidity increases, whit the exception of the area marked with a lighter gray
